Evaluation of All State Owned Land and Buildings at Hawthorn Center

Required by Section 822k of Public Act 268 of 2016

Department of Technology, Management and Budget
State Facilities Administration
February 27, 2017

Hawthorn Center Assessment

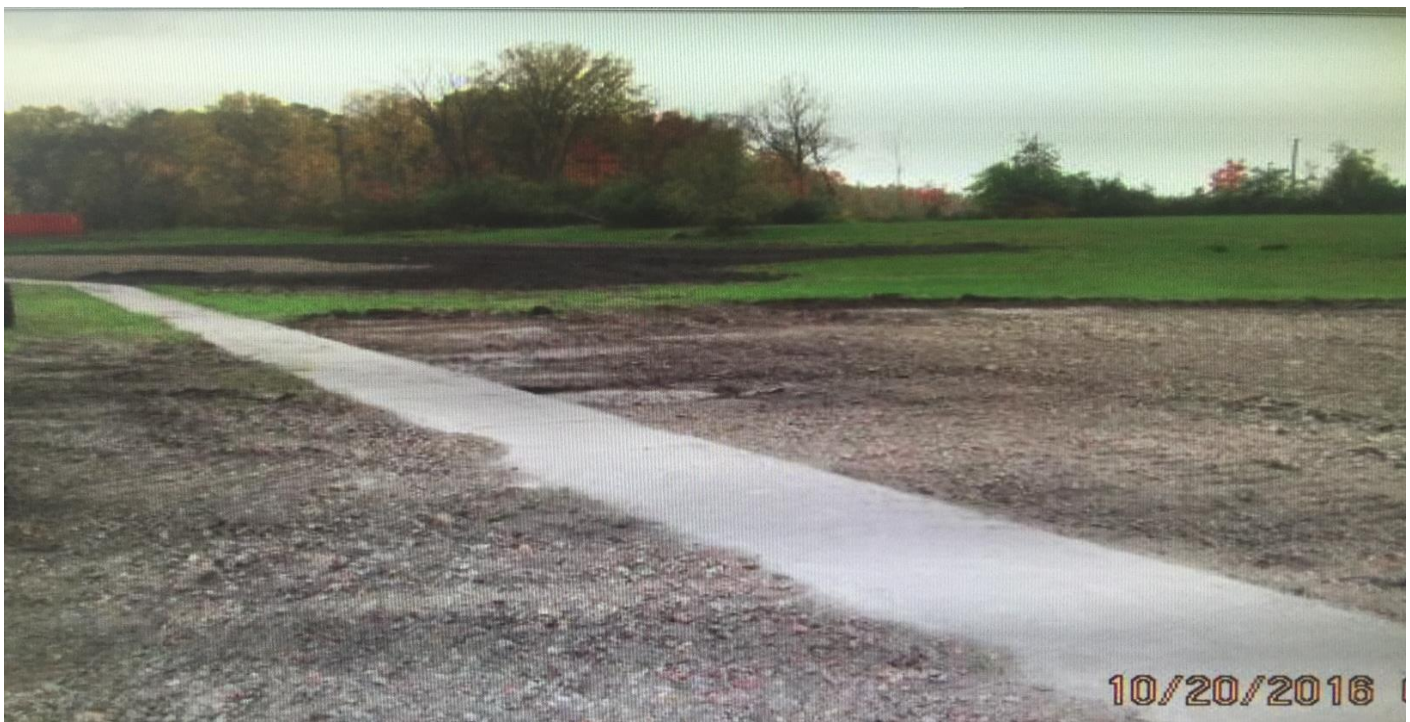
Summer 2016:

Cottage Conditions: (Cottages were demolished in Summer of 2016) See Picture Below:

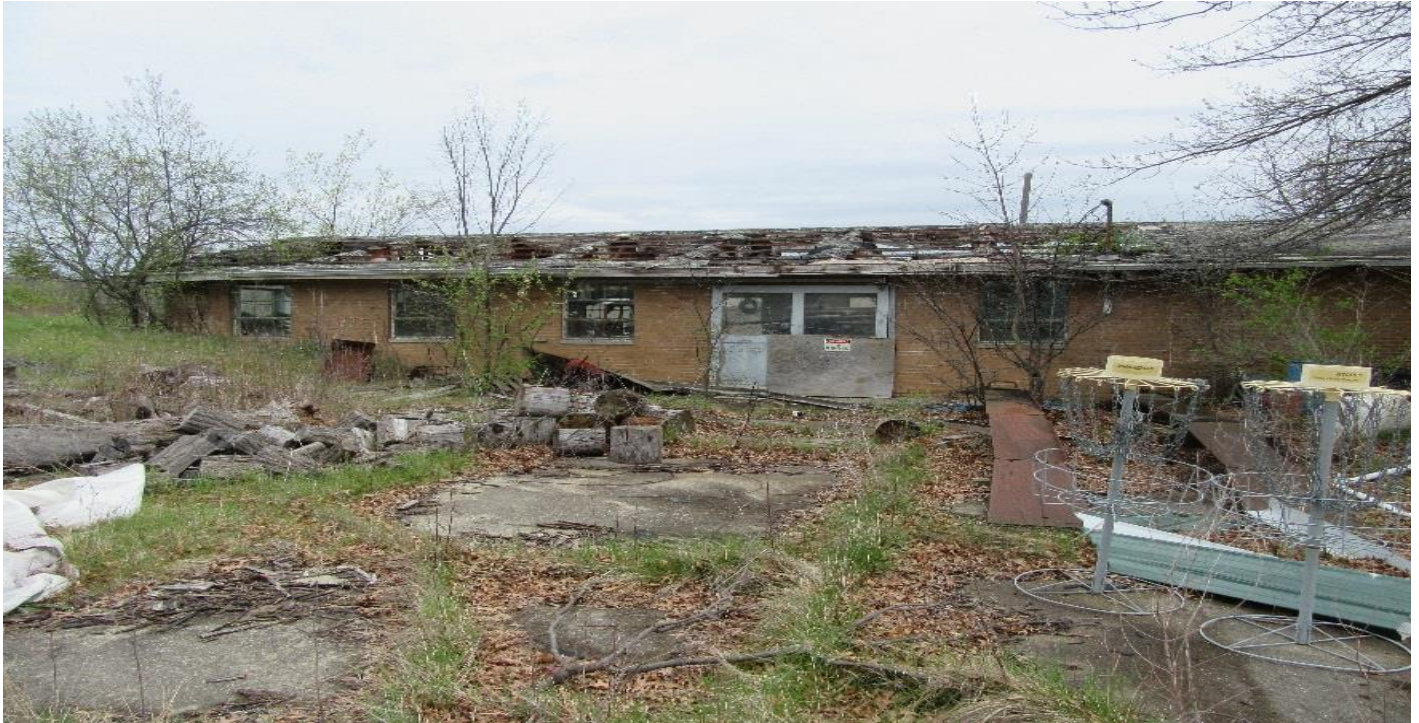
April 2016 – Prior to Demolition:

- The five cottages – four residential and one for auto services – were abandoned in 2005 without being properly sealed/closed. Utilities have been cut off and the buildings have been allowed to deteriorate and are now failing and caving in.
- The floors and ceilings are caving in.
- Some windows are missing and some doors are open, making it accessible to anyone who tries to enter. This is a serious risk as the buildings could cave in as well as the mold and asbestos that are in the buildings.
- There is residential property within 2000 feet.
- The road to the cottages is broken and has at least one large hole that could cause harm if someone stepped into it.
- The cottages are unsafe to enter because of the threat of collapse, animal infestation, and exposed asbestos.
- These structures should be properly demolished immediately. Estimated cost \$25-30,000 each.

Abandoned cottages - NOTE: Demolished Summer 2016. These pose an imminent threat to anyone who may enter the buildings and must be demolished to eliminate the risk. Each building would cost approximately \$30,000, or \$150,000 total. Costs may be higher depending on level of asbestos and the remediation required.

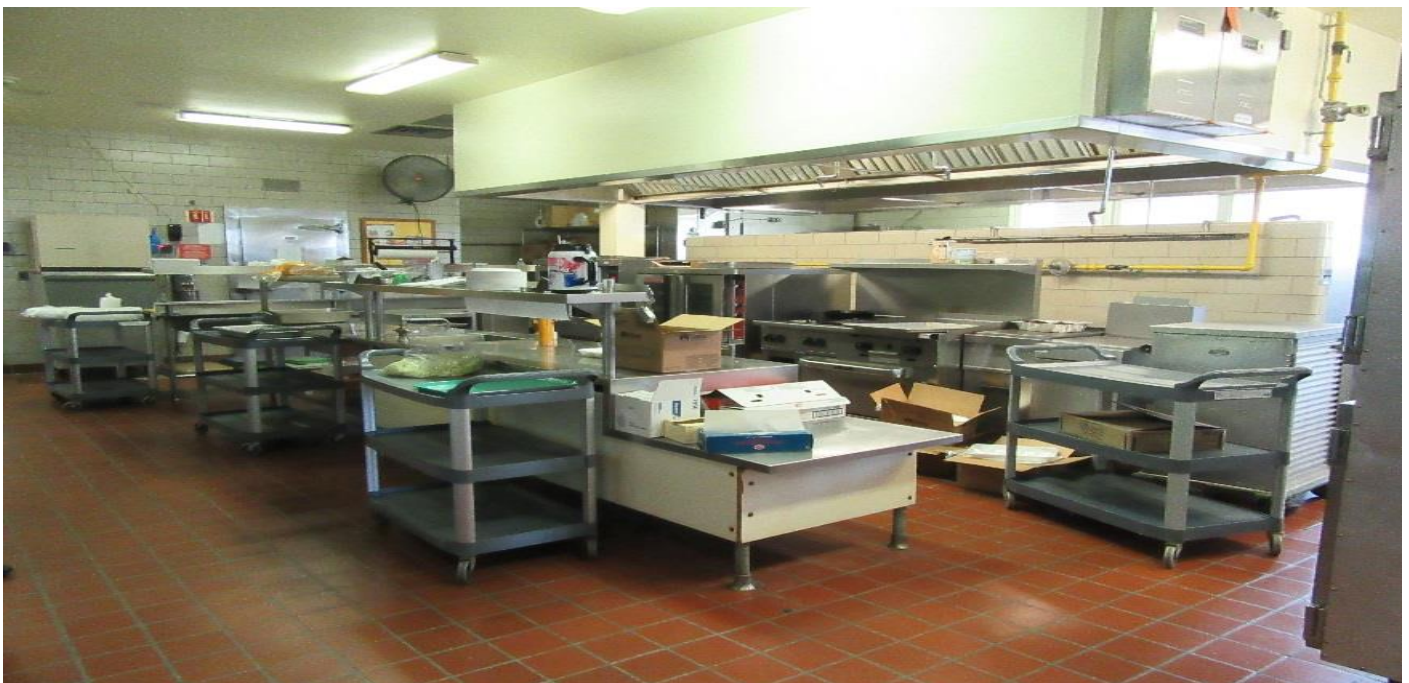
- There are two kitchens. One that is not in service in the south wing and one in current operation in the main building. The kitchen currently being utilized is the larger of the two.
- The smaller kitchen is out of service because of drainage issues.
- All meals are prepared in the main building kitchen and transported a great distance to the residents in the south wing.
- The kitchen serves 70 now, down from the maximum of 350 at its peak.
- There are five appliances in the operating kitchen.

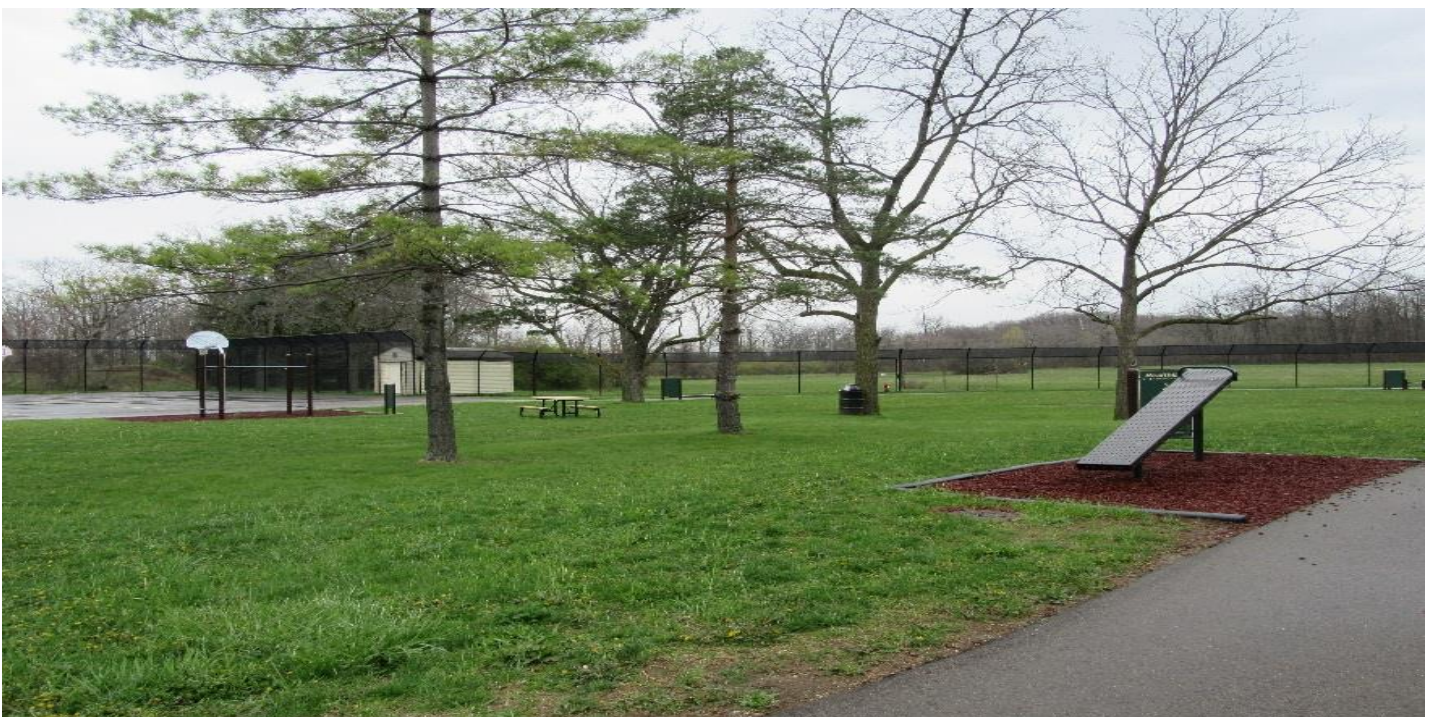
The grounds are well maintained by the Hawthorn maintenance staff. There are two freight containers used for storage. They would be better served, aesthetically and functionally, by pole-barns or unused areas of the building.
